[Docket No. FAA-2012-0807; Directorate Identifier 2011-NM-191-AD]

Airworthiness Directives; Airbus Airplanes

ACTION: Supplemental notice of proposed rulemaking (NPRM); reopening of comment period.

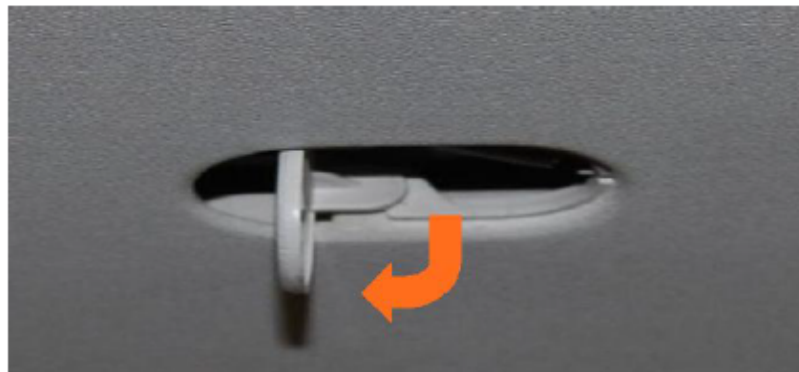
Picture B:

(7) The requirements of paragraphs (g) and (h) of this AD apply only to passenger oxygen containers that are Design A, as defined in figure 1 to paragraph (i)(7) of this AD.

Design A: The placard on the passenger oxygen container test button is as described in Picture A of Appendix 1 of this AD. The Mask configuration ("ZZ" in Picture A) is a number and the test button is as shown in Picture B.
